Title: 2019 Megasun Illumination System Modifications and Operating Procedure Updates

2019 MegaSun Illumination System

Modifications and Operating Procedure Updates

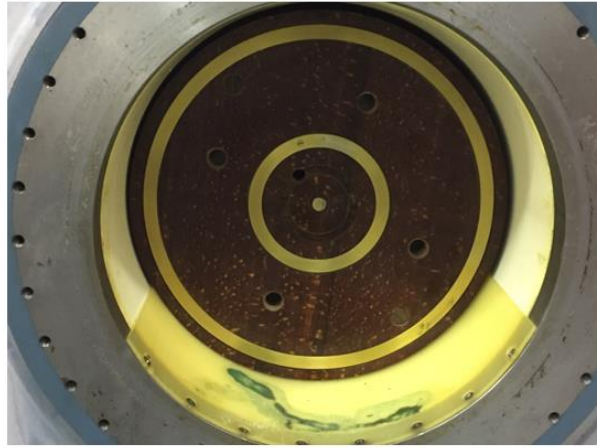
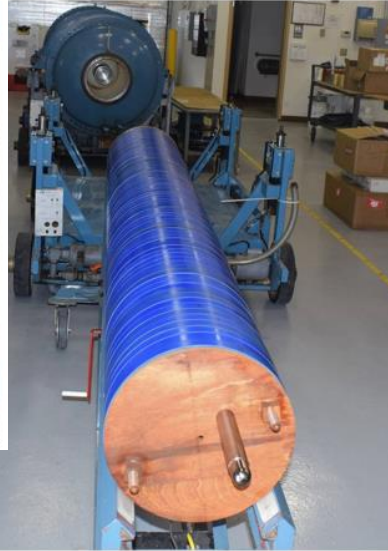
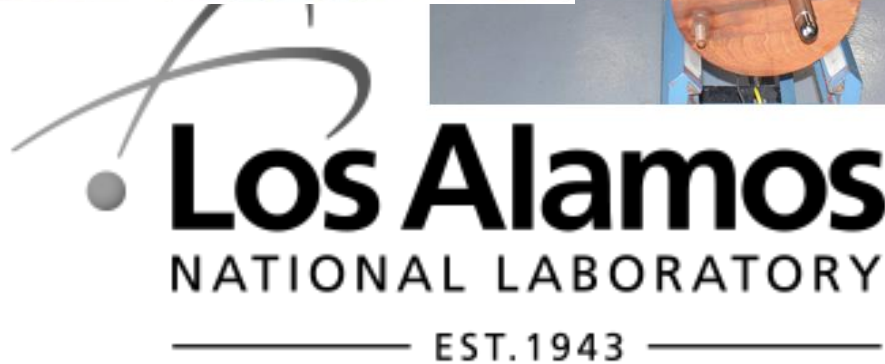
- May 2019 Febetron Shock Incident
- Worker was following procedure
- The X-ray pulser was undergoing maintenance due to multiple malfunctions
- After meeting with Occupational Medicine, the worker was allowed to come back to work without restrictions

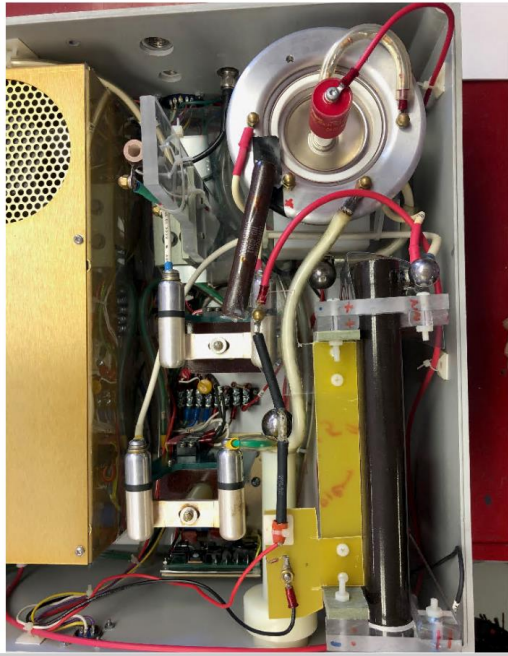
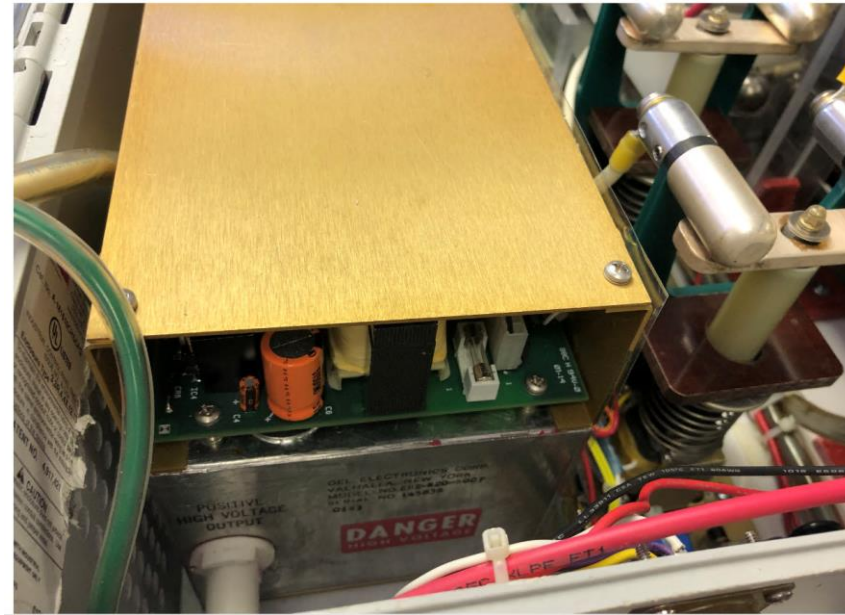
- After discussion on the schematics given by the manufacturer, we decided to open up the cabinets, starting with the 2001 design.
